TRANSFORT MAINTENANCE FACILITY MASTER PLAN

**6570 Portner Road
Fort Collins, Colorado 80525**

December, 2021

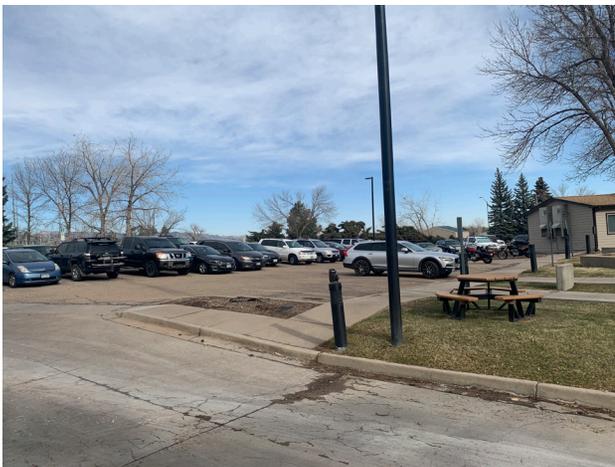
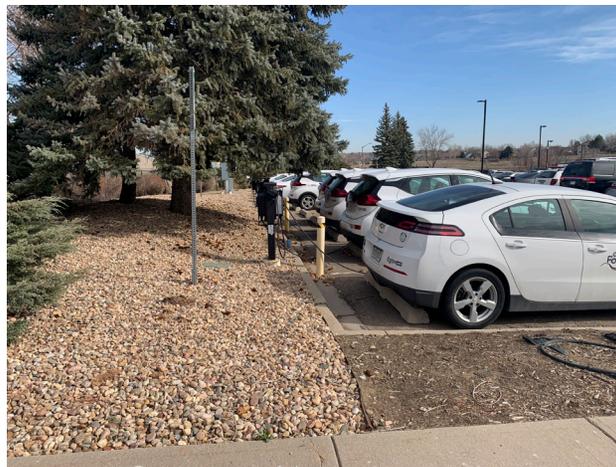
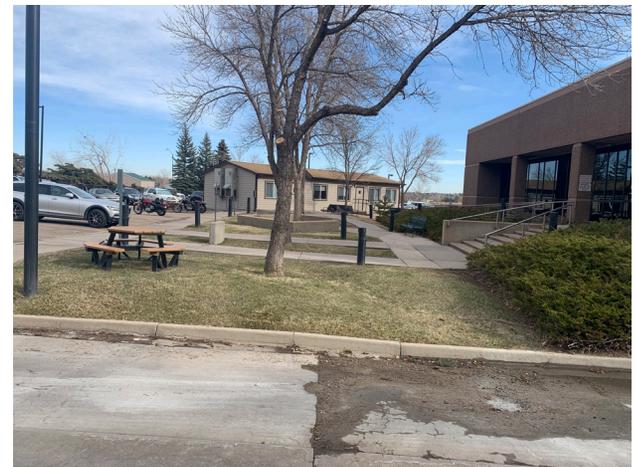
[2] West Building Entrance

This existing building entrance is an important aesthetic focal point for entry to the facility and site/landscape improvements should support this. Consider:

- Moderate hardscape improvements. Remove or partially remove existing walks, plaza, stairs, ramps, seat walls, furniture, and railings and develop a new design.
- Major landscape improvements. Remove all existing landscape areas and replace with new plant species that better speak to the landscaping philosophies of the City: native, water-wise, appropriate selections.
- Provide improved seating, lighting, signage, and overall aesthetics.
- Preserve and protect existing trees

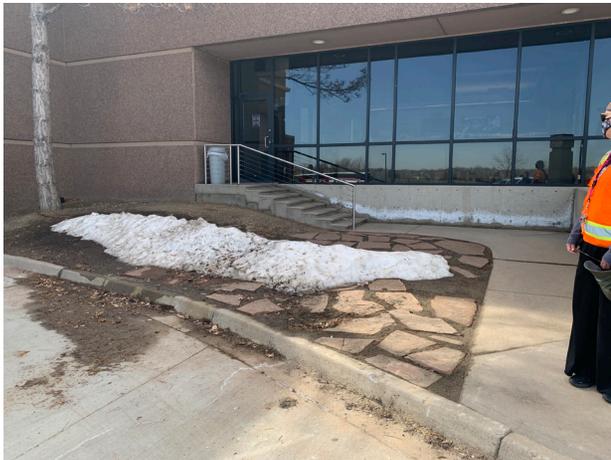
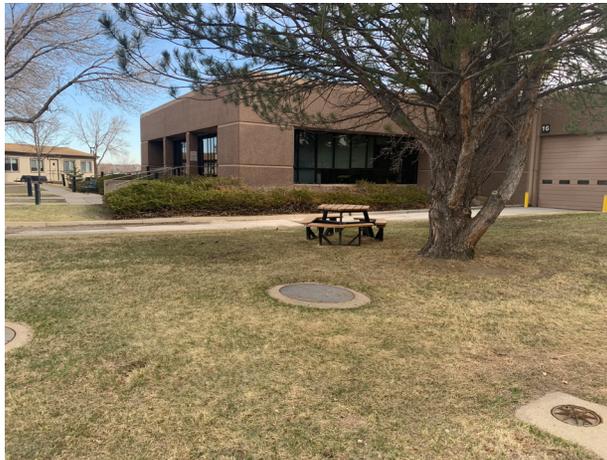
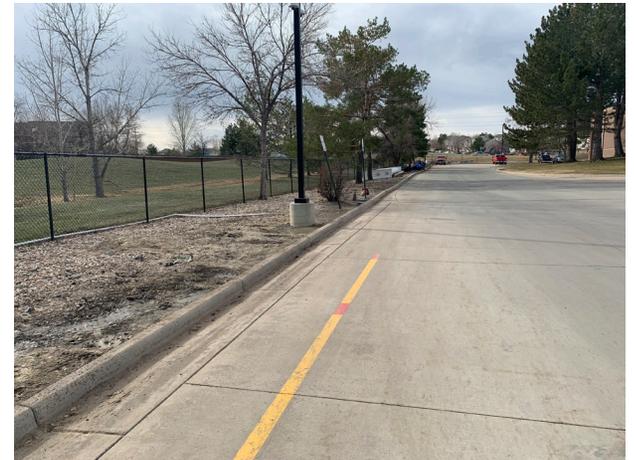
With relatively large areas of concrete and asphalt that require snow removal, the landscape areas surrounding the site have been damaged.

- Provide landscape between the designated snow storage areas using large, hardy, salt-tolerant shrubs to provide a visual buffer to adjacent neighborhoods. Set back plantings from curb and provide landscape boulders where appropriate to create a buffer from road salts and de-icers..

- Provide designated snow storage areas that are clearly marked with signage. Consider concrete pads for larger snow storage areas to minimize damage from snow removal operations.

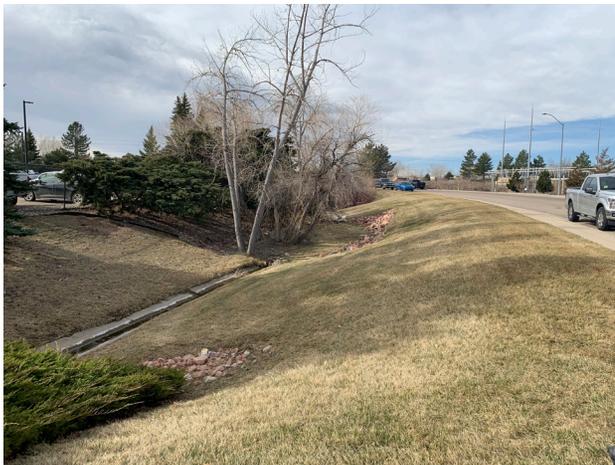
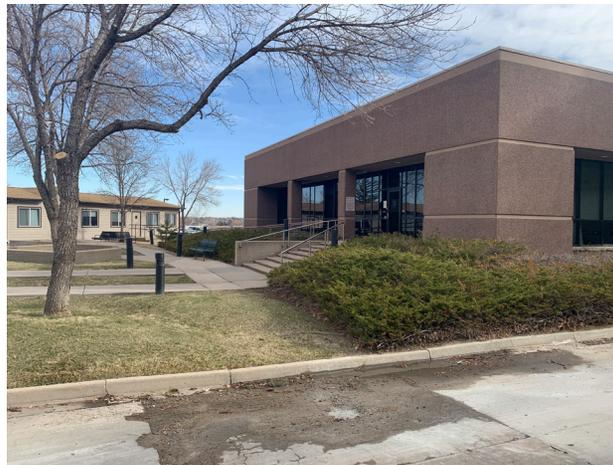
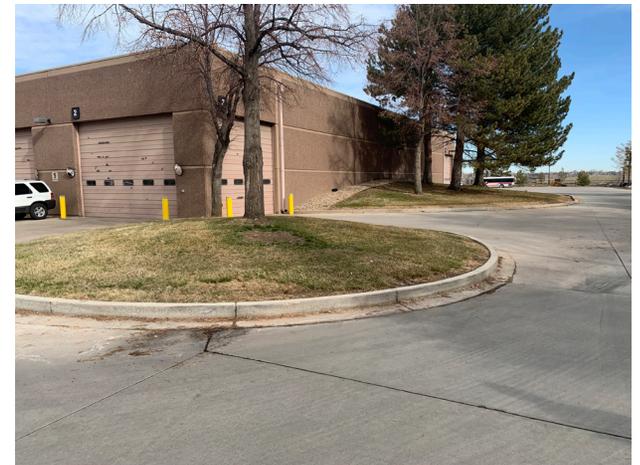
The two long swales along Portner Road with concrete pans at the bottom appear to be in good condition. Some areas have seen significant plant growth over and around the swales, though seem to be healthy and mature and only add to the buffering between the building and public right-of-way. It is recommended no action is taken to change or improve these so long as they function properly and drain these swales to storm lines effectively.

Several areas throughout the site have low-spots on concrete or asphalt that are not draining adequately. It is recommended a grading assessment be made prior to site-wide improvement to ensure these are addressed properly. In addition, there appears to be a water leak near the southeast entry drive that should be investigated and repaired.

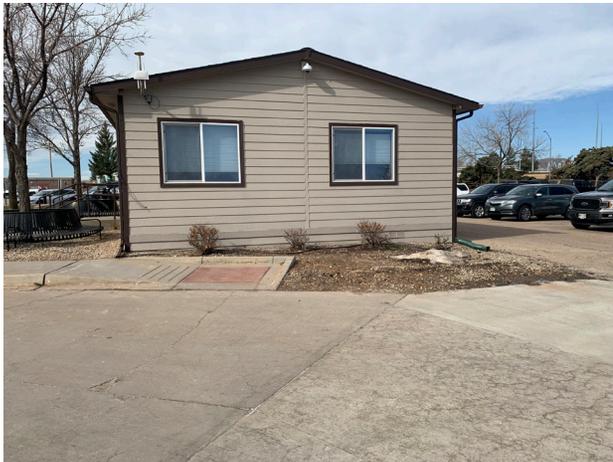
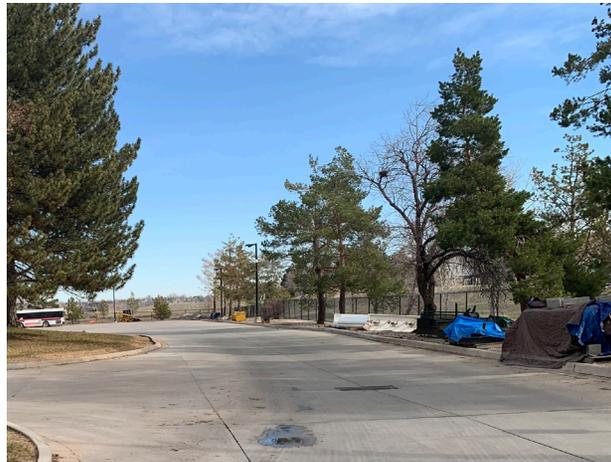
[13] Miscellaneous Landscaping

A handful of other minor landscape improvements can be made to make this site more appealing.

- Remove juniper plant species. They have become unsightly and a maintenance burden. There are some that are not highly visible and may provide habitat and environmental benefits that may be assessed to remain.
- Wherever there may be suggested landscape improvements, replacing plants with native, water-wise, and climate appropriate plants is recommended.
- The small landscape area on the north end of the building, at the ends of the island that contains EV Charging stations should be renovated with plantings added.
- The small landscape area on the north end of the modular building contains some existing plants, but could be improved. Irrigation should be provided to this area.

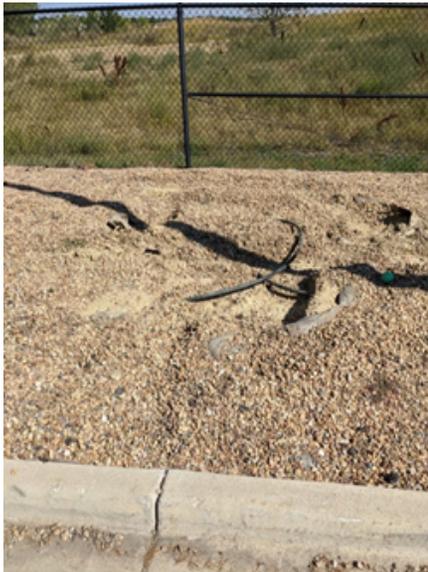
Concern was expressed during the site visit that individual trees in rocked shrub beds are dying and it's suspected that the existing drip loops were not providing sufficient water to the trees. No concerns were expressed about the turf and native grass sprinklers or for shrub bed drip irrigation. Concern was expressed about the west parking lot with regard to grading and how any overspray or rain collects in low spots.

[Left photo] Tree Drip Lateral Loop - Dead tree removed and drip lateral loop remains.

- g. Tree Rings – Rain Bird XFCV-06-12 dripline (three loops per tree)
 - h. Gate Valve – Nibco T113 (2.5-inch and smaller), Matco 10RT (3-inch and larger)

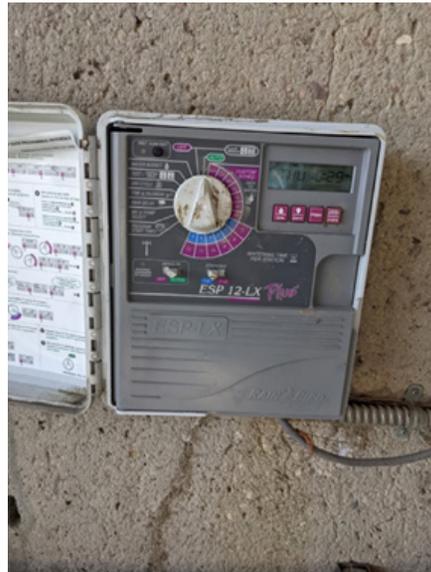
The existing irrigation controller is a standalone Rain Bird ESP-12-LX controller, and no rain sensor was observed. The existing irrigation controller does not make automated runtime adjustments based on weather conditions to conserve water.

It was not apparent that the existing irrigation system uses a master valve and/or flow sensor to automate the shut down the irrigation system due to catastrophic pipe breakage, provide leakage warnings (ie. broken sprinklers), and to report water use data.

[Right photo] Existing irrigation controller

- m. Rotor Sprinkler – Rain Bird 5000 series (medium range), Rain Bird Falcon (large range)
- n. Irrigation Controller – Weathertrak ET (traditional or two wire decoder)
- o. Wire Splices – 3M DBR/Y-6
- p. Valve Boxes – Rain Bird PVB Series (green lids in turf, brown lids in mulch or rock areas)

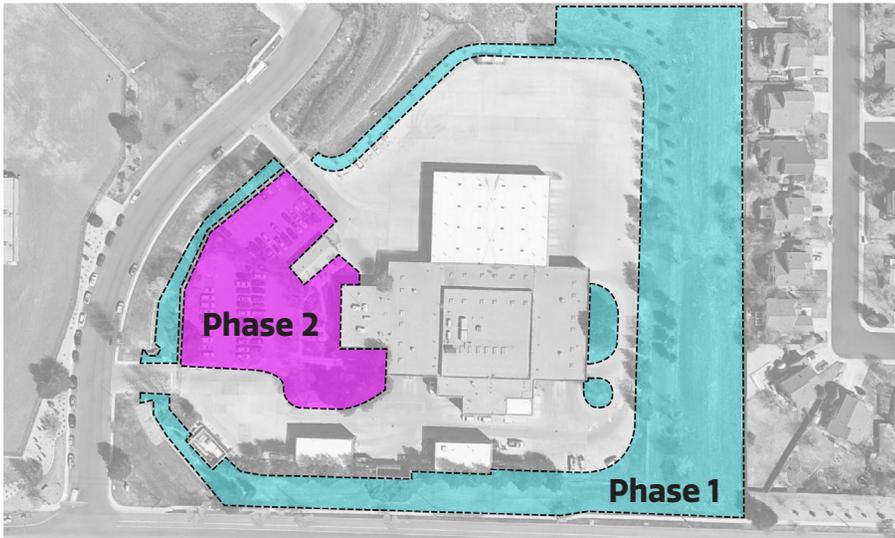
The Opinion of Cost is broken into two phases as per the phasing plan on this page. The opinion of cost associated with Phase 2 improvements are landscape related estimates only. Other assessments with additional consultants will be required to fully understand the scope of phase 2 improvements.
